12
PTPT REPORT NO. 78-6
AFPEA PROJECT NO. 77-P7-42

"OUT OF CONTAINER" HANDLING ANALYSIS
OF THE LN-15 INERTIAL MEASUREMENT UNIT

HQ AFALD/PTP
AIR FORCE PACKAGING EVALUATION AGENCY
Wright-Patterson AFB OH 45433

March 1978

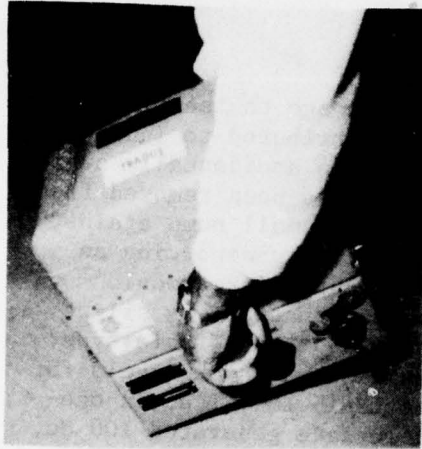
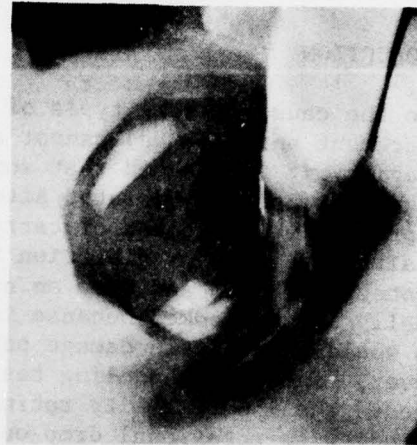
Figure 2. IMU Begins Rotating After Lift

Since the cause of some types of shipping damage to inertial measurement units (IMUs) cannot always be attributed to inadequate packaging, it is assumed that some IMUs may be accidentally bumped, knocked, dropped or vibrated after the item has been removed from its protective container or carrying case. A small bump against the aircraft frame or vibration from a vehicle transporting an unprotected IMU to and from an aircraft or supply area would normally be overlooked because it is assumed that a very slight bump would have little damage potential to an item of this type. However, "in-house" handling tests revealed that shock levels far exceeded the 15G fragility rating of the LN-15 IMU; i.e., a one-inch edgewise rotational drop on a hard surface generated 100 Gs. This simulated a situation wherein an individual's fingers slipped out from under one end of the IMU during lifting.

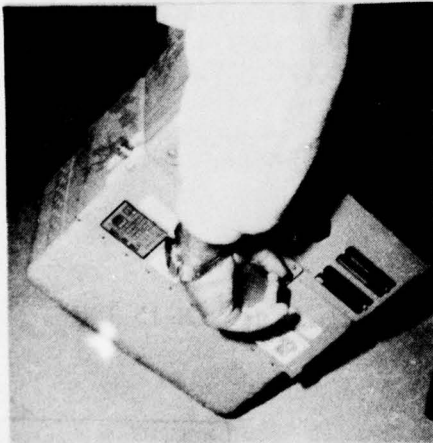
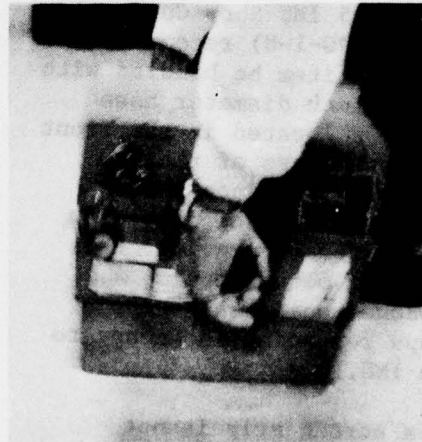
Figure 3. Complete Rotation

If the grip friction is reduced by water from perspiration, oil or other contaminant, the IMU could rotate a full 180° as shown in Figure 3.

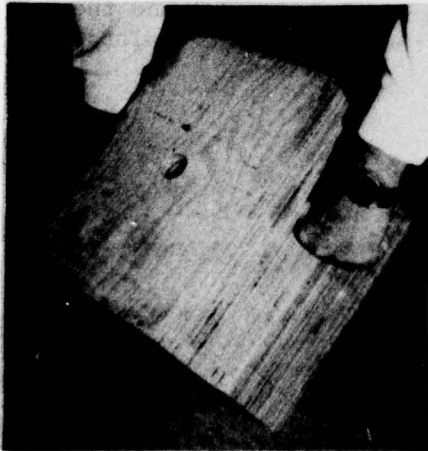
Figure 5. Hose Fitting Lift Technique with Model

Simulated hose fittings were added to the wooden model of the LN-15 (Figure 4) and the "hose fitting" lift technique was performed. During the lifting process, the model was allowed to rotate and hit the floor (Figure 5).

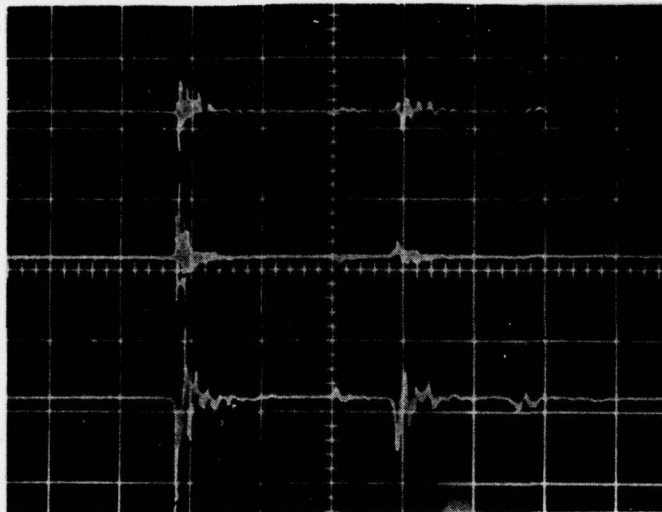
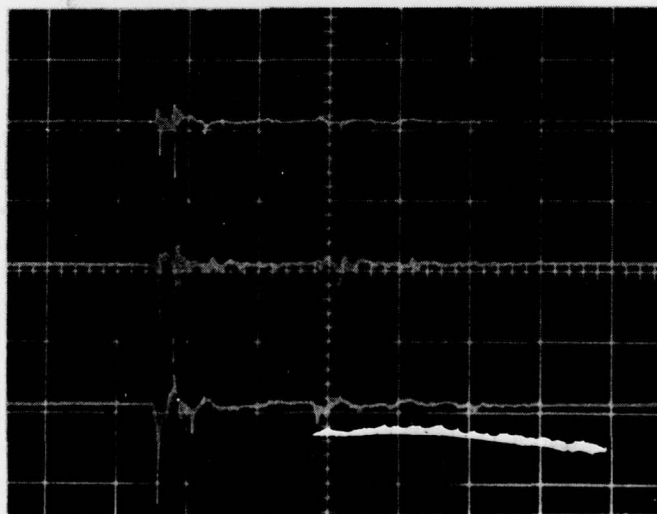
Figure 8. Oscilloscope Traces of One-Inch Drop

The oscilloscope traces of the one-inch edgewise rotational drop are shown in Figure 8. Note the similarity between the wave form of the simulated model (a) and the actual item (b).

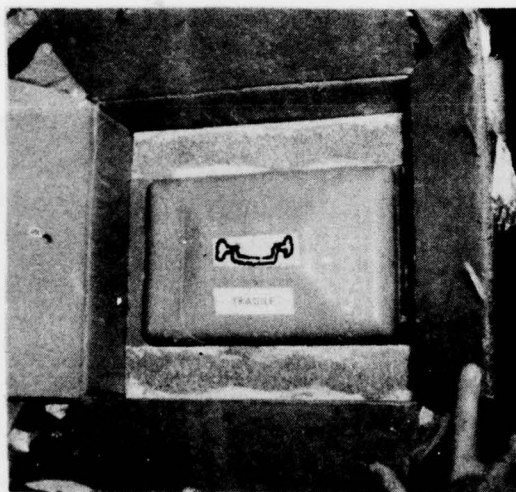
Figure 9. Handle Location

1. The probability of damage occurring to the LN-15 is relatively high during removal from the protective container and subsequent handling.
2. Since it is difficult to prevent accidental shocks, a handling aid, such as a handle, could reduce the amount of damage. A special handling device which can be removed, is not recommended because studies have shown that these aids are not always used.

1. Incorporate a fold-type handle in the top of the IMU shell as shown superimposed on the photograph in Figure 9. This handle should be an integral part of the shell.
2. Re-emphasize, to all personnel, the importance of proper handling of fragile IMUs.
